**Banks Pointe Subdivision**  
**Roadway Improvements**

September 2015

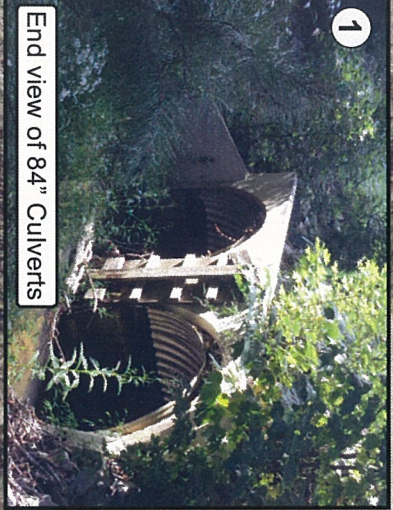
End view of 84" Culverts

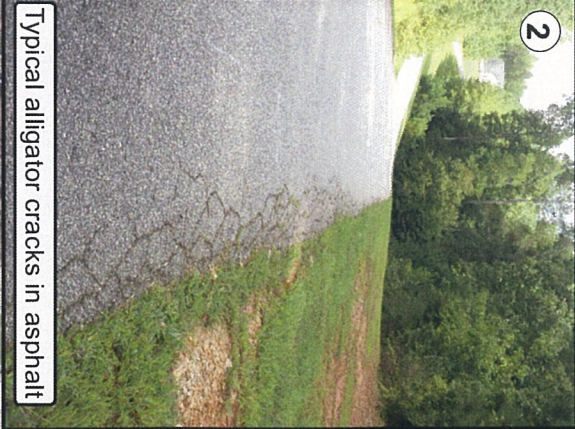
Typical alligator cracks in asphalt

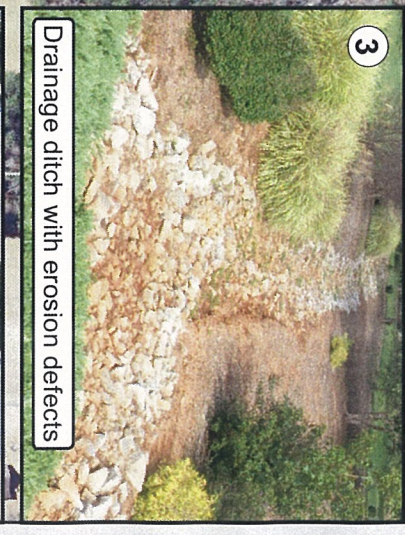
Drainage ditch with erosion defects

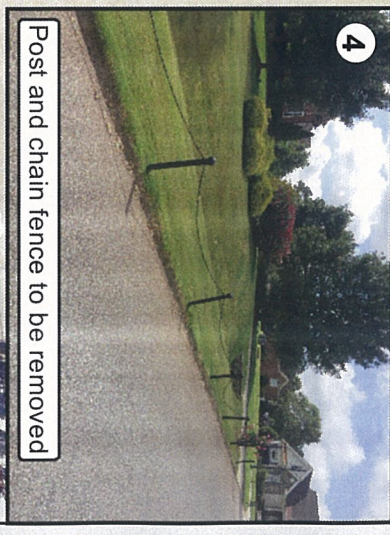
Post and chain fence to be removed

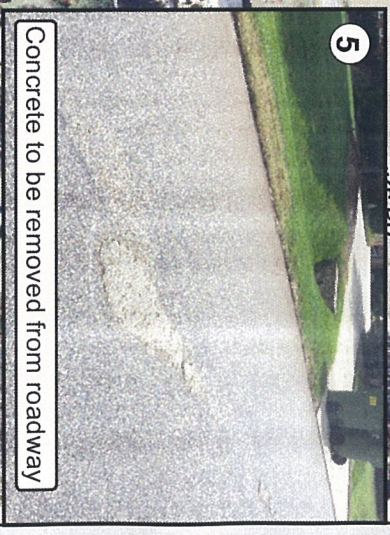
Concrete to be removed from roadway
